Test Report

Product Name : Fanless In-Vehicle Computer

Report No.:SZAEEK191217003-01-M1

Client Name : Shen Zhen JHC Technology Development Co.,LTD
Address : B, 3rd Fl, A Block Junxiangda Bldg., No.9 Zhongshanyuan Rd. West,
Tongle Village, Nanshan District, Shenzhen City, China, 518052
Report on the submitted sample(s) said to be:
Product Name : Fanless In-Vehicle Computer
Basic Model No:SIGM-2650/S002
Model : Serial Model No:SIGM-2650/S001, SIGM-2650/S003, SIGM-2650/S004
SIGM-2650/T001, SIGM-2650/T002, SIGM-2650/T003,SIGM-2650/T004
Trademark : JHCTECH
Description : /
Sample(s) received quantity : 2pcs
Sample(s) Testing quantity : 2pcs
Manufacturer : Shen Zhen JHC Technology Development Co.,LTD
Factory : Shen Zhen JHC Technology Development Co.,LTD
Other information : /
Sample(s) received Date : 2019.12.16
Testing period : 2019.12.19 - 2020.1.2
Report Date : 2020.03.13

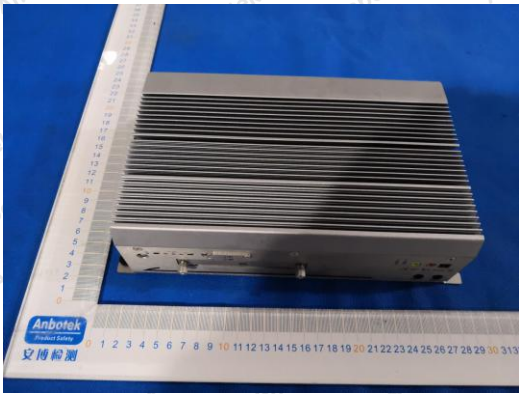
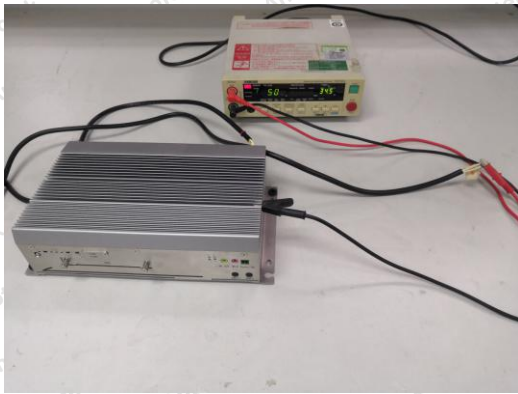
The equipment could work as intended and within its specified limits .
				Pass
Photos

Before test		Test Set-up Insulation resistance test

Test Method	EN 50155:2017			
Test Condition	1. Insulation resistance test: 500V (DC) 2. Voltage withstand test: 1000V (AC), 50HZ, 1 minute 3. During the test, the equipment shall not be powered on			
Test Equipment	Equipment Name	Equipment No.	Equipment model	Equipment Cal validity period
	Insulation Resistance Tester	SE-2167	TOS7200	2020.4.2
	Withstand voltage tester	SE-2174	TOS5101	2020.4.2
Test Requirement	1. Insulation resistance after pressure test >100 MΩ 2. Neither disruptive discharge nor flashover shall occur during the voltage withstand test. Withstand voltage test current ≤10mA. 3. After the withstand test, the equipment shall work as intended and within its specified limits.			
Test Result	Sample No.	Test Result		
	SZA EK 191217 003-1-2 -1	Insulation resistance (MΩ)		Voltage withstand test
		Before voltage withstand test	After voltage withstand test	
		>5000	>5000	Neither disruptive discharge nor flashover occurred. Withstand voltage test current <10mA.

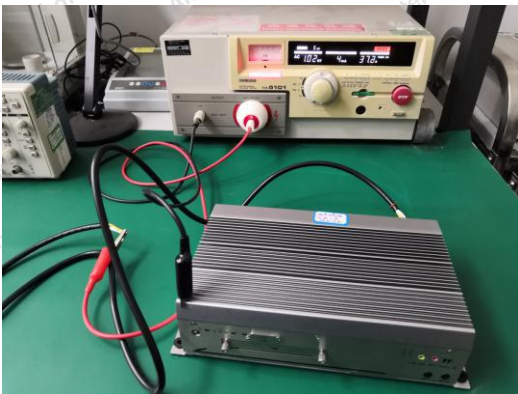
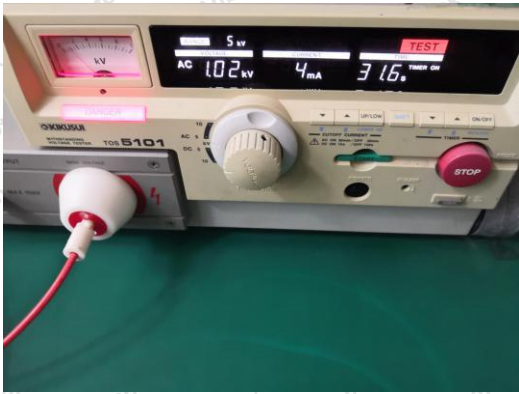
Test set-up Insulation resistance test	Test Set-up Voltage withstand test

/
	Test Set-up Voltage withstand test	/

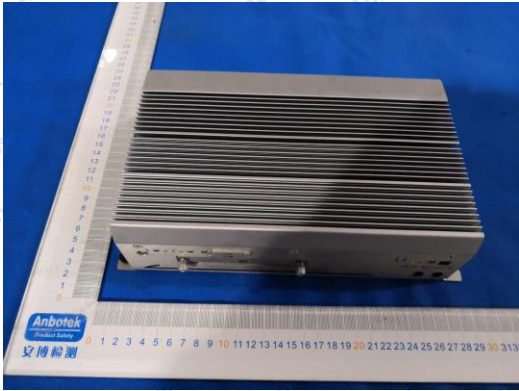
Before test		Test set-up

Test Method	According to EN 50155:2017 and client's requirements		
Test Condition	The equipment can operate normally and The indicators of each channel are normal after the sample is powered on.		
Test Requirement	The equipment can operate normally and The indicators of each channel are normal after the sample is powered on.		
Test Result	Sample No.	Test Result	Conclusion
	SZA EK191 217003-1-2- 1	The equipment can operate normally and The indicators of each channel are normal after the sample is powered on.	Pass
Photos

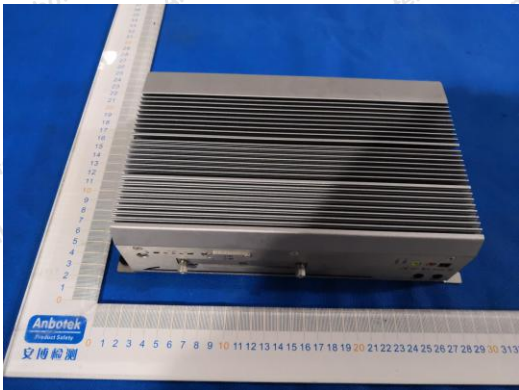
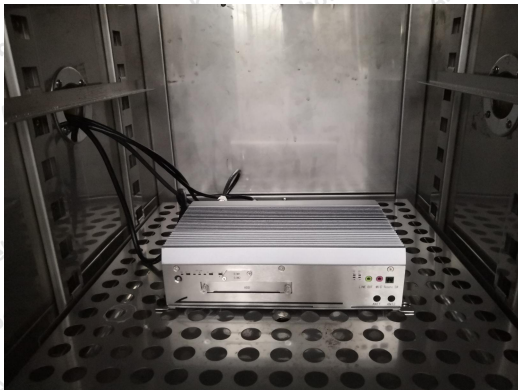
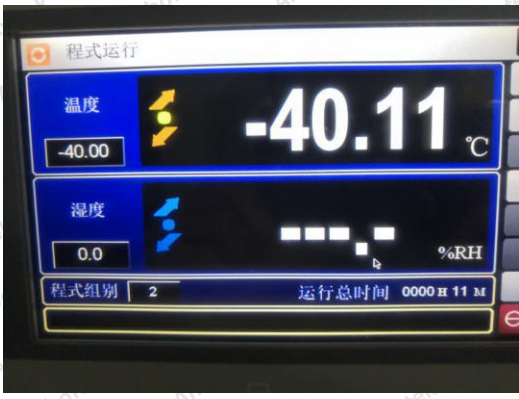
Before test		Test set-up

/	
	Test set-up		/

Test Method	EN 50155:2017			
Test Condition	The equipment is placed in a chamber at -40℃ for 16h without any voltage applied. After recovery, a performance check is carried out at ambient reference temperature.			
Test Equipment	Equipment Name	Equipment No.	Equipment model	Equipment Cal validity period
	Temperature & humidity chamber	SE-3301	ZJ-HWS1000C	2020.8.22
Test Requirement	After recovery, the equipment shall work as intended and within its specified limits: 1.The apparatus shall continue to operate as intended during and after the test/event. 2.No degradation of performance or loss of function is allowed.			
Test Result	Sample No.	Test Result		Conclusion
	SZAEEK191217003-1-2-1	After recovery, the equipment could work as intended and within its specified limits. The equipment can operate normally and The indicators of each channel are normal after the sample is powered on.		Pass
Photos

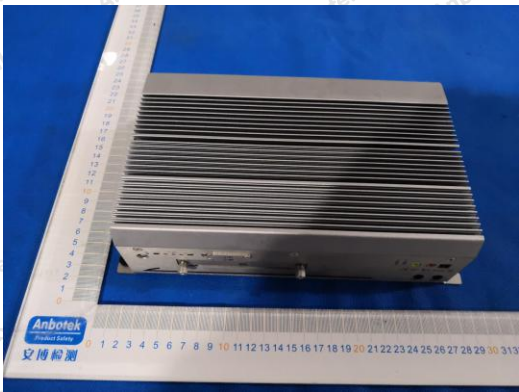
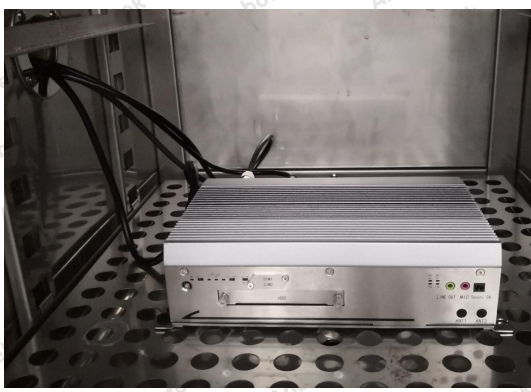
Before test		Test set-up

Test Method	EN 50155:2017			
Test Condition	<p>The low operating temperature is -40℃.</p> <p>The equipment is placed without any voltage applied, after thermal stabilization of the chamber at-40 ℃, for 2 h to achieve stabilization.</p> <p>At the end of this period the equipment shall be switched on and a performance check is carried out, keeping the equipment at the low temperature.</p> <p>After recovery, this performance check is repeated at normal room temperature.</p>			
Test Equipment	Equipment Name	Equipment No.	Equipment model	Equipment Cal validity period
	Temperature & humidity chamber	SE-3301	ZJ-HWS1000C	2020.8.22
Test Requirement	<p>During and after the test, the equipment shall work as intended.</p> <p>1. The apparatus shall continue to operate as intended during and after the test.</p> <p>2. No degradation of performance or loss of function is allowed.</p>			
Test Result	Sample No.	Test Result		Conclusion

SZA EK191217003-1-2-1	After recovery, the equipment could work as intended and within its specified limits. The equipment can operate normally and The indicators of each channel are normal after the sample is powered on.		Pass
Photos

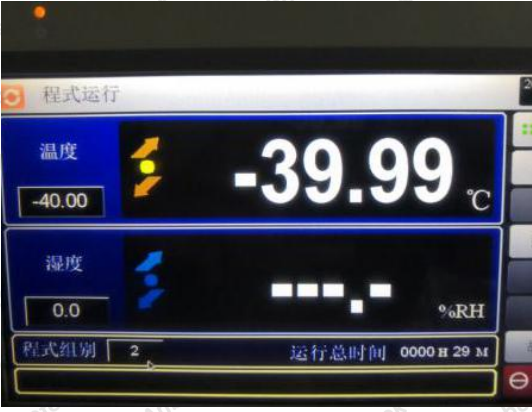
<p>Test set-up</p></div>	<div>

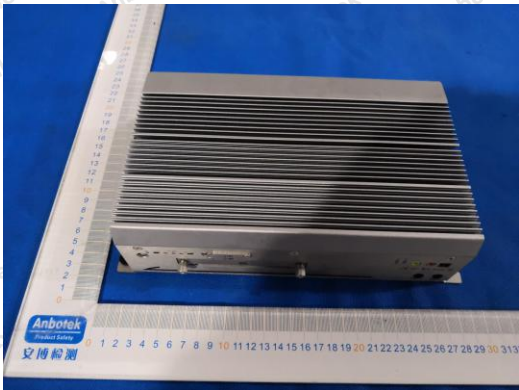
Before test		Test set-up

Test Method	According to EN 50155:2017 and client's requirements			
Test Condition	<p>Rise the temperature from room temperature to 70 °C at 1 °C/min, stable for 6h, then the equipment shall be switched on operational checks carried.</p> <p>Rise the temperature to 85°C at 1 °C/min, left for 10 min with continuous operational checks carried.</p> <p>The equipment is then allowed to cool to ambient temperature and a further performance test.</p>			
Test Equipment	Equipment Name	Equipment No.	Equipment model	Equipment Cal validity period
	Temperature & humidity chamber	SE-3301	ZJ-HWS1000C	2020.8.22
Test Requirement	<p>During and after the test, the equipment shall work as intended.</p> <p>1. The apparatus shall continue to operate as intended during and after the test.</p> <p>2. No degradation of performance or loss of function is allowed.</p>			
Test Result	Sample No.	Test Result		Conclusion
	SZAEEK191217003-1-2-1	After recovery, the equipment could work as intended and within its specified limits. The equipment can operate normally and The indicators of each channel are normal after the sample is powered on.		Pass

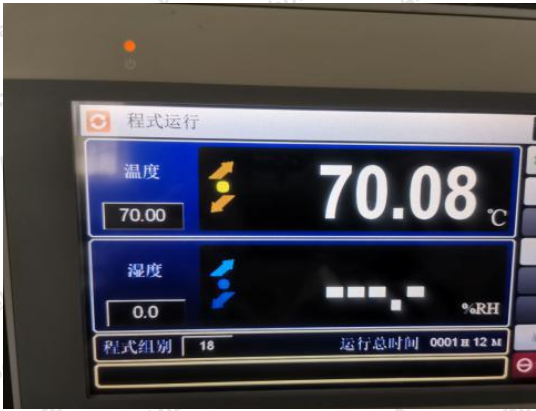
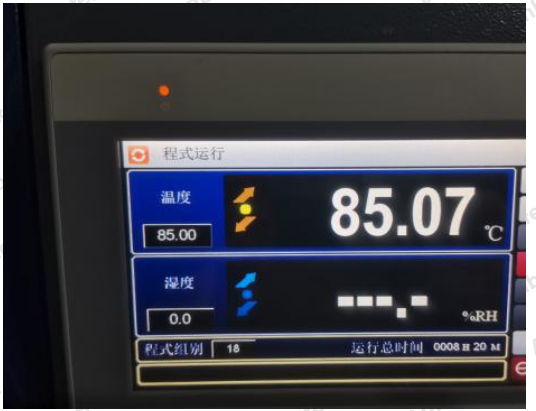
Test set-up	Test set-up

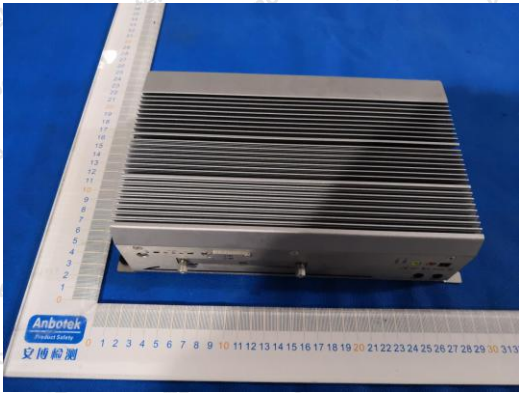
Before test	Test set-up

Test Method	EN 50155:2007				
Test Condition	The equipment under test shall not be powered except during the performance check. Temperatures: 55℃ and 25℃ Number of cycles:2 Test time:2×24h Intermediate measurements:an operational check shall be carried out at the rise in temperature during the beginning of the 2nd cycle. Insulation resistance test: 500V (DC) Withstand voltage test: 1000V (AC), 50HZ, 1 minute.				
Test Equipment	Equipment Name	Equipment No.	Equipment model	Equipment Cal validity period	
	Temperature & humidity chamber	SE-3301	ZJ-HWS1000C	2020.8.22	
	Insulation Resistance Tester	SE-2167	TOS7200	2020.4.2	
	Withstand voltage tester	SE-2174	TOS5101	2020.4.2	
Test Requirement	1.The results of all insulation and performance test(results after the first and second cycles)shall be within the specified tolerances and operation performance respectively. 2.Before and after the test(initial and final voltage withstand and insulation), the equipment shall work as intendeds specified limits 1) The apparatus shall continue to operate as intended during and after the test. 2) No degradation of performance or loss of function is allowed.

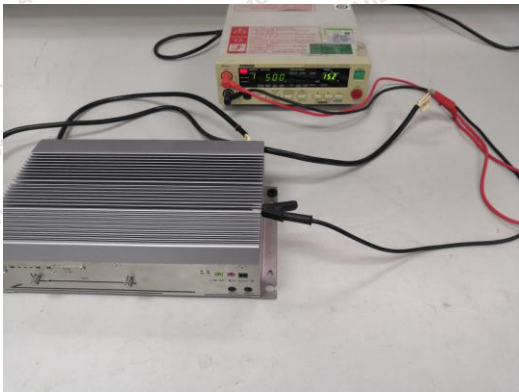
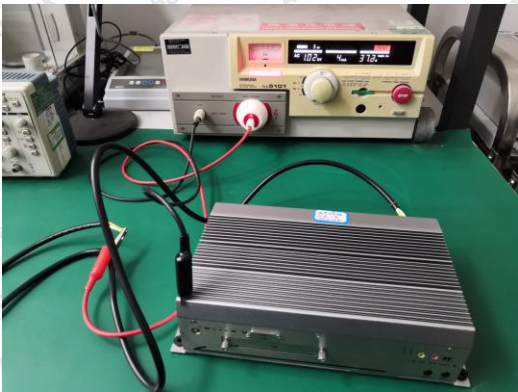
After test	After test

Test Result	Sample No.	Test Item	Initial	Final	Conclusion
	SZA EK 191217 003-1-2 -1	Insulation resistance	>5000 MΩ	>5000 MΩ	Pass
		Withstand voltage	Neither disruptive discharge nor flashover occurred. Withstand voltage test current <10mA.	Neither disruptive discharge nor flashover occurred. Withstand voltage test current <10mA.	
		After recovery, the equipment could work as intended and within its specified limits. The equipment can operate normally and The indicators of each channel are normal after the sample is powered on.

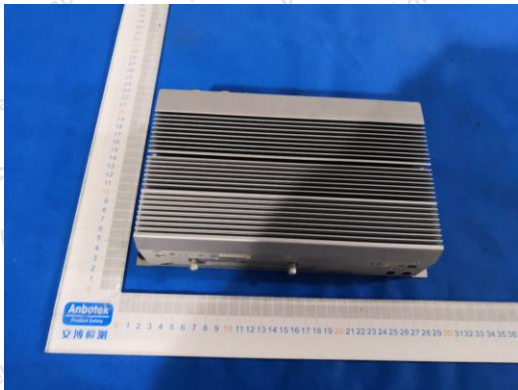
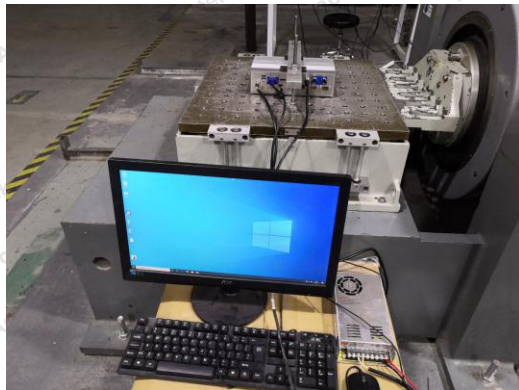
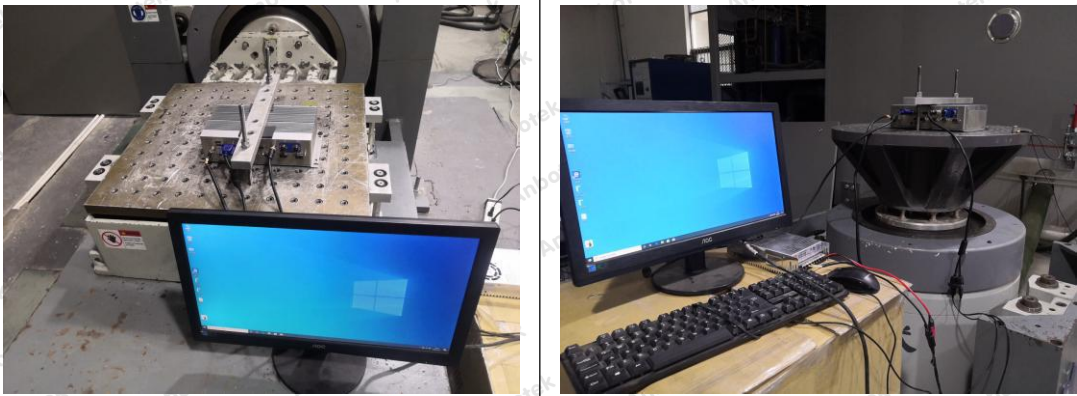
Before test		Test set-up(X)

Test set-up(Y)	Test set-up(Z)

Test Method	EN 50155:2017			
Test Condition	1 Class B	Direction	RMS(m/s ²)	Frequency
		Vertical	1.01	5Hz ~ 150Hz
		Horizontal	0.45	
		Longitudinal	0.70	
	Test time	10 min per direction.		
Test mode	power on			
Test Equipment	Equipment Name	Equipment No.	Equipment model	Equipment Cal validity period
	Vibration tester	SE-1199	DC-2200-26	2019.12.25
Test Requirement	1.No damage shall occur during the test 2.During the test, the equipment shall work as intended. 1) The apparatus shall continue to operate as intended during and after the test. 2) No degradation of performance or loss of function is allowed.			
Test Result	Sample No.	Test Result		Conclusion
	SZAEK19121 7003-1-2-2	1. No damage occurred during the test. 2. During the test, the equipment could work as intended.		Pass
Photos

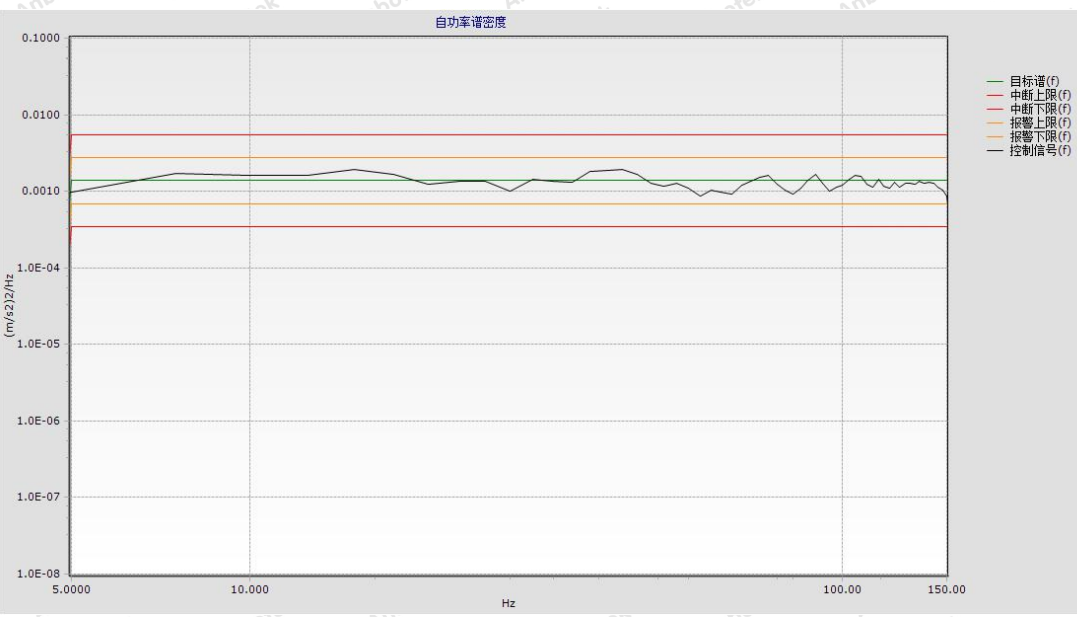
Test spectrogram(X)

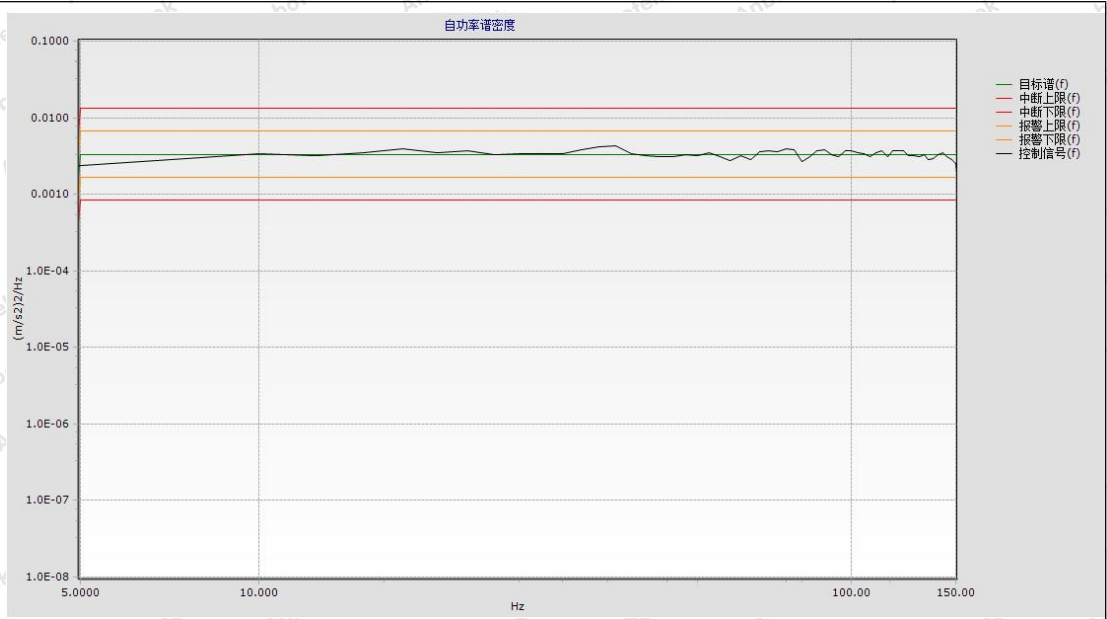
Test spectrogram(Y)

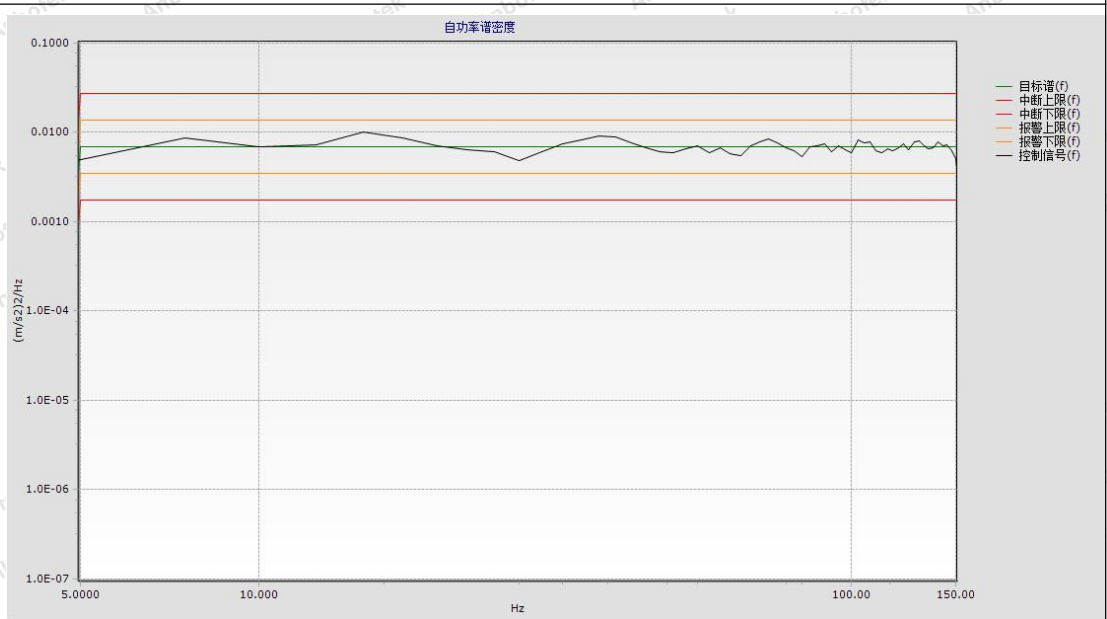
Test spectrogram(Z)

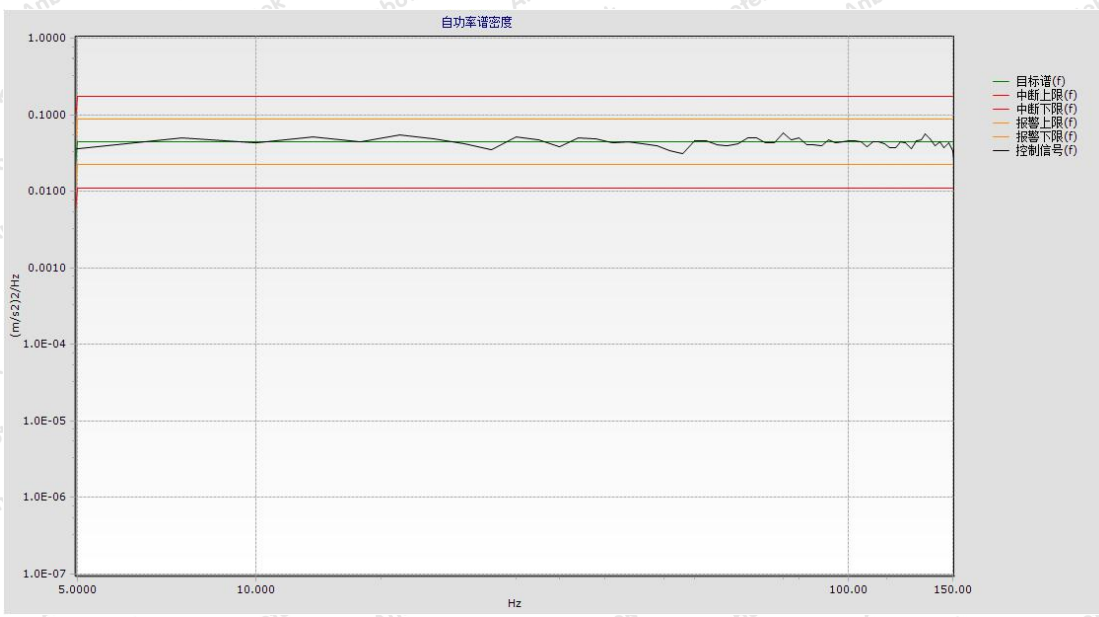
Test spectrogram(X)

Test Method	EN 50155:2017			
Test Condition	1 Class B	Direction	RMS(m/s²)	Frequency
		Vertical	5.72	5Hz ~ 150Hz
		Horizontal	2.55	
		Longitudinal	3.96	
	Test time	5 hours per direction.		
Test mode	power off			
Test Equipment	Equipment Name	Equipment No.	Equipment model	Equipment Cal validity period
	Vibration tester	SE-1199	DC-2200-26	2019.12.25
Test Requirement	1.No damage shall occur during the test 2.after the test, the equipment shall work as intended. 1) The apparatus shall continue to operate as intended after the test. 2) No degradation of performance or loss of function is allowed.			
Test Result	Sample No.	Test Result		Conclusion
	SZAEK19121 7003-1-2-2	1. No damage occurred during the test. 2. During the test, the equipment could work as intended.		Pass
Photos

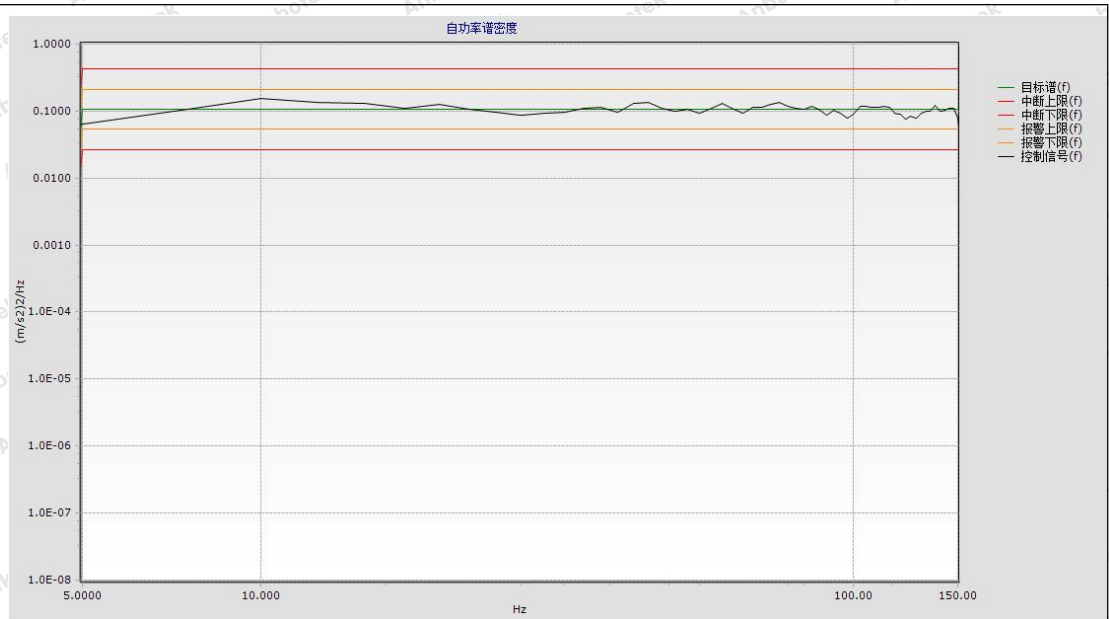
Test spectrogram(Y)

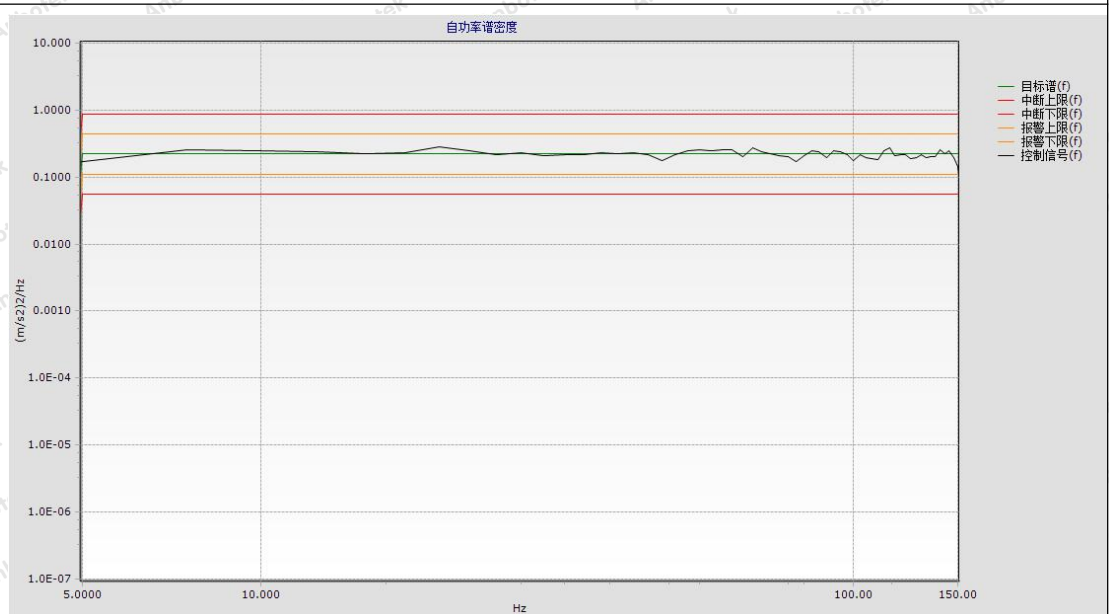
Test spectrogram(Z)

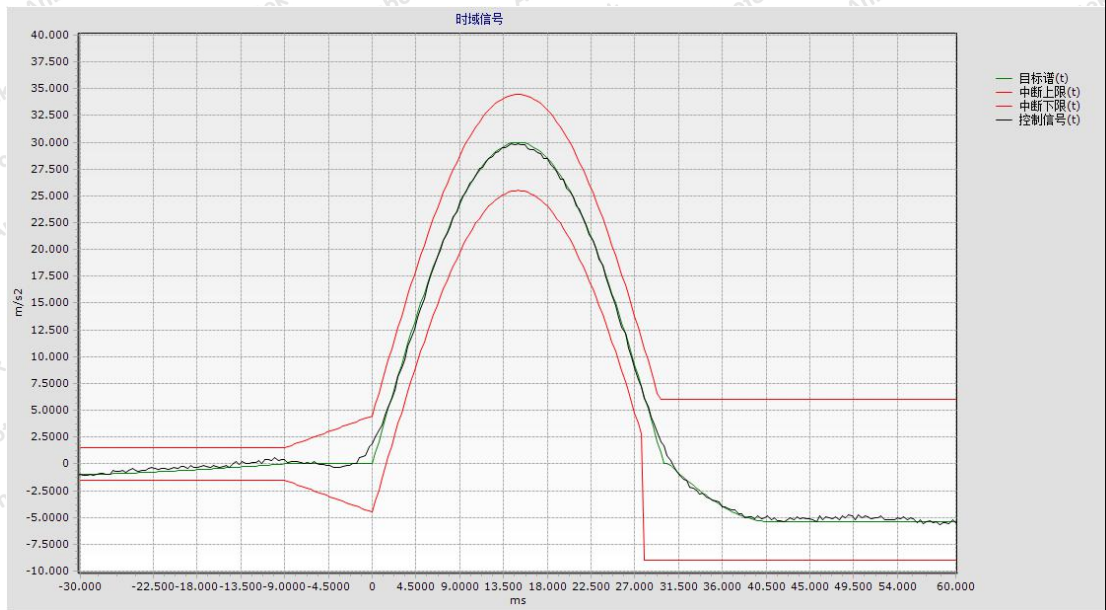
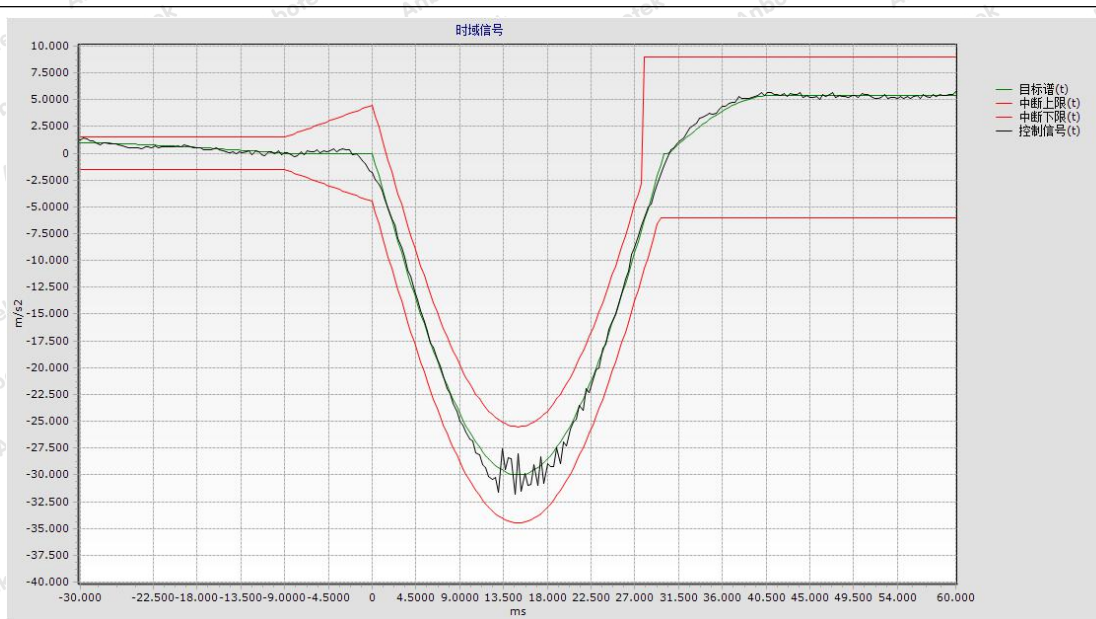
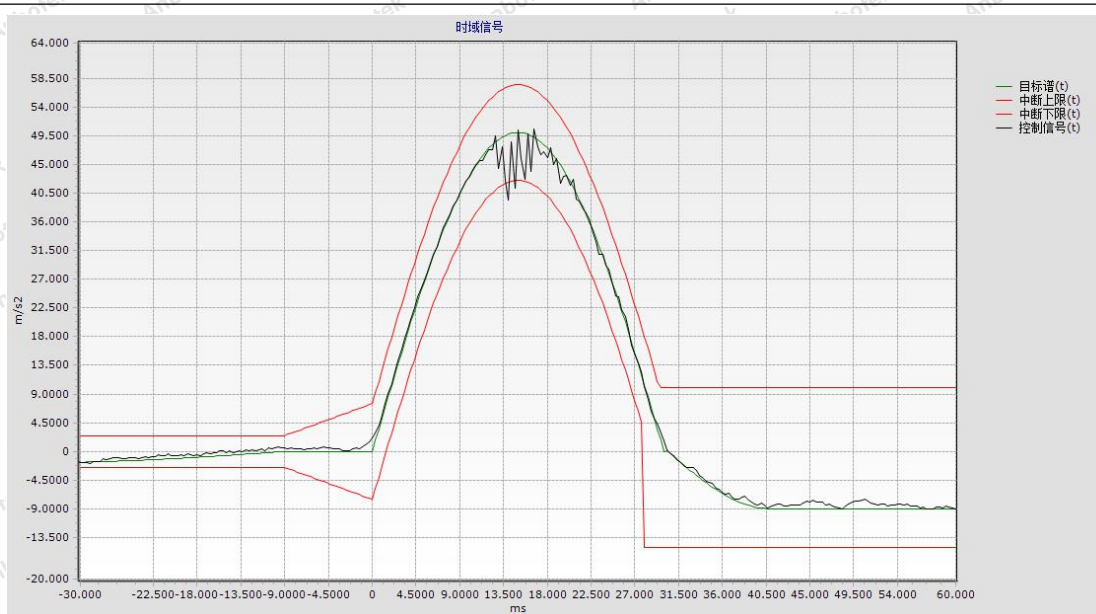
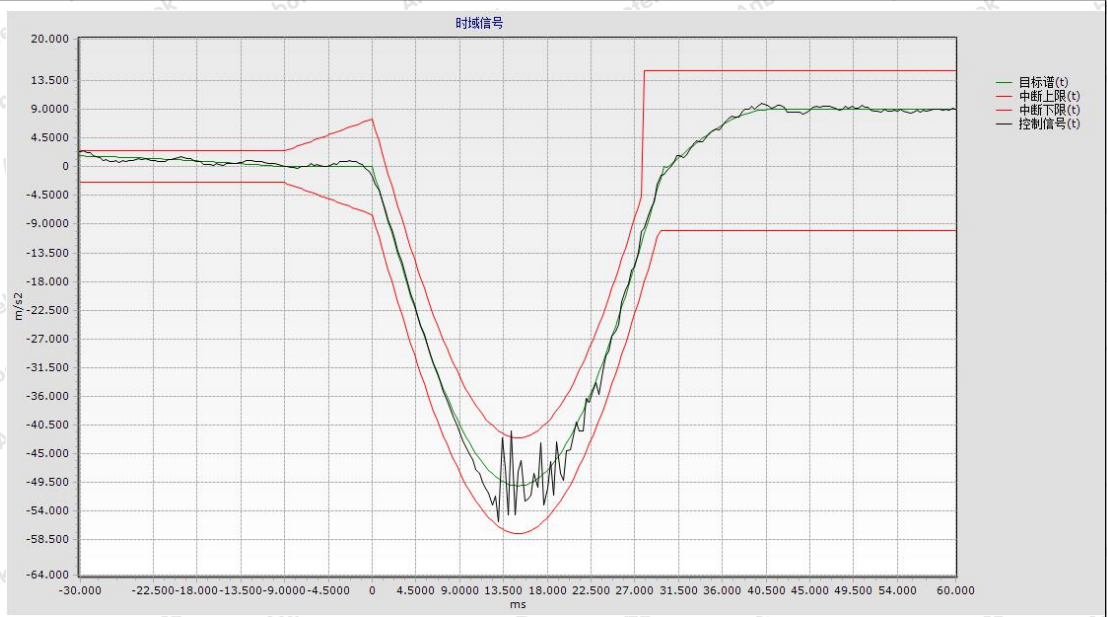
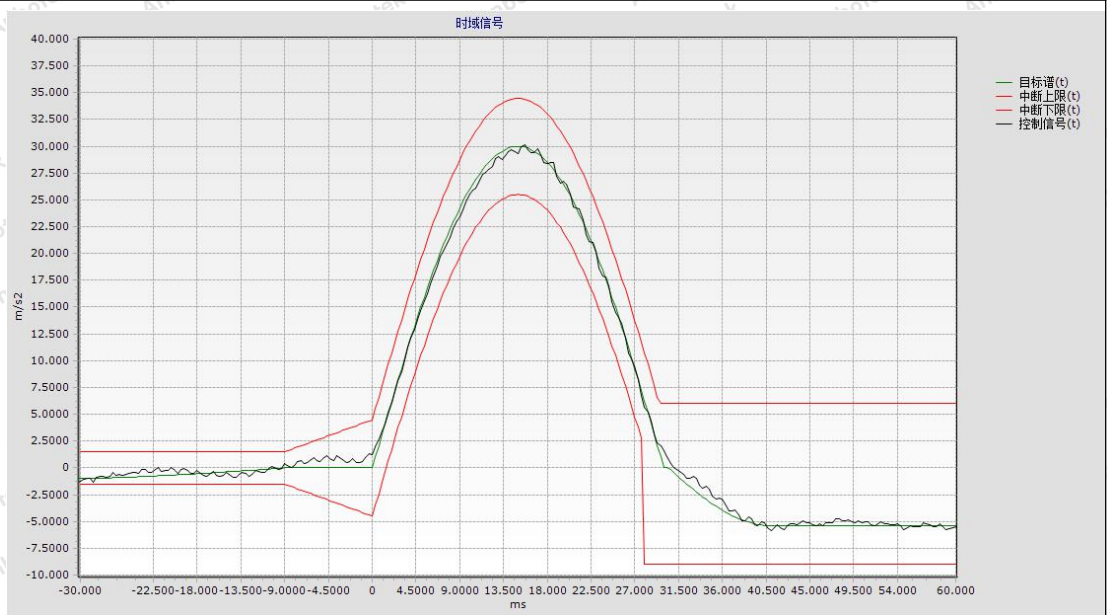
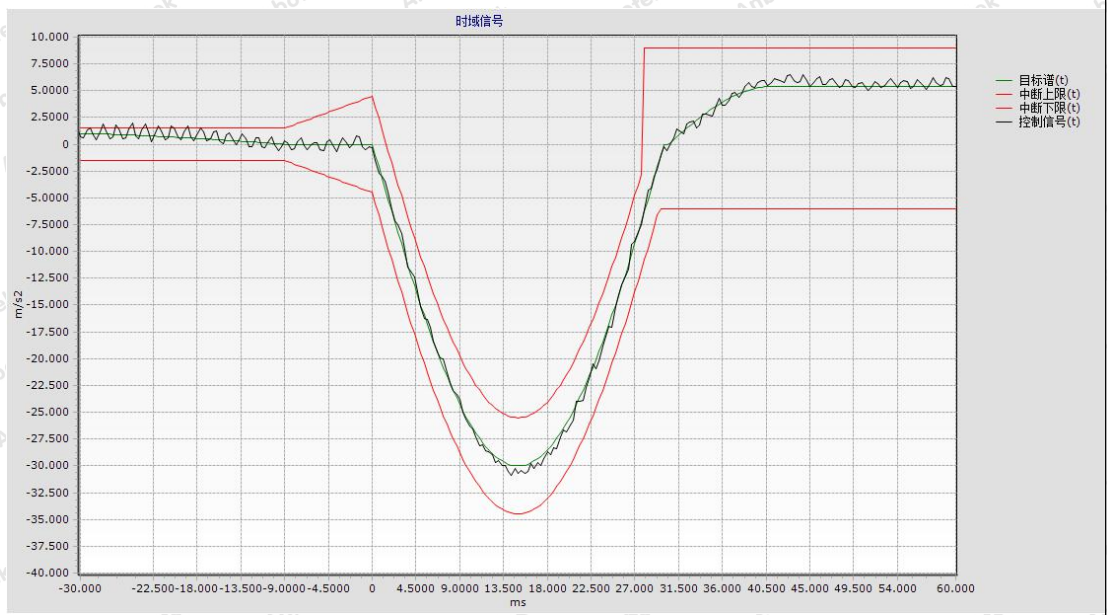
Test spectrogram(+X)

Test spectrogram(-X)

Test spectrogram(+Y)

Test spectrogram(-Y)

Test spectrogram(+Z)

Test spectrogram(-Z)

Test Method	EN 50155:2017			
Test Condition	Classification	Direction	Acceleration(m/s ²)	Pulse width(ms)
	1 Class B	Vertical	30	30
		Horizontal	30	30
		Longitudinal	50	30
	Test time	3 times in each direction, 18 times in total		
Test Equipment	Equipment Name	Equipment No.	Equipment model	Equipment Cal validity period
	Vibration tester	SE-1199	DC-2200-26	2019.12.25
Test Requirement	1.No damage shall occur during the test 2.after the test, the equipment shall work as intended. 1) The apparatus shall continue to operate as intended after the test. 2) No degradation of performance or loss of function is allowed.			
Test Result	Sample No.	Test Result		Conclusion
	SZAEK19121 7003-1-2-2	1. No damage occurred during the test. 2. after the test, the equipment could work as intended.		Pass
Photos

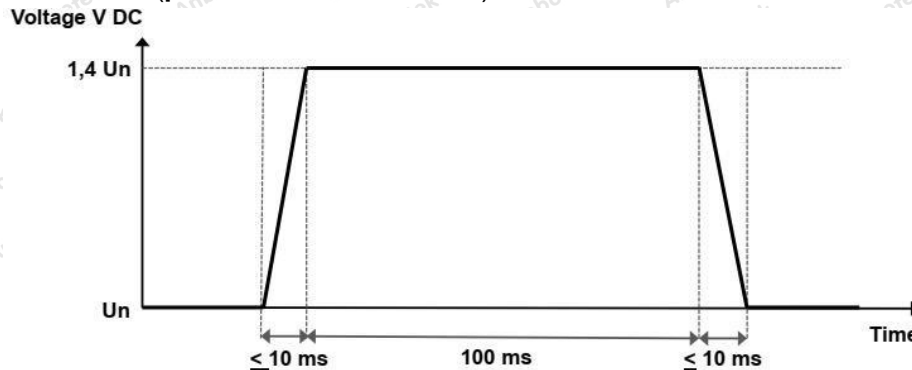
Temporary supply overvoltages up to $1,4 U_n$ lasting no more than 0,1 s shall not cause deviation of function (**performance criterion A**).

Figure 6 — Temporary supply overvoltages (a)

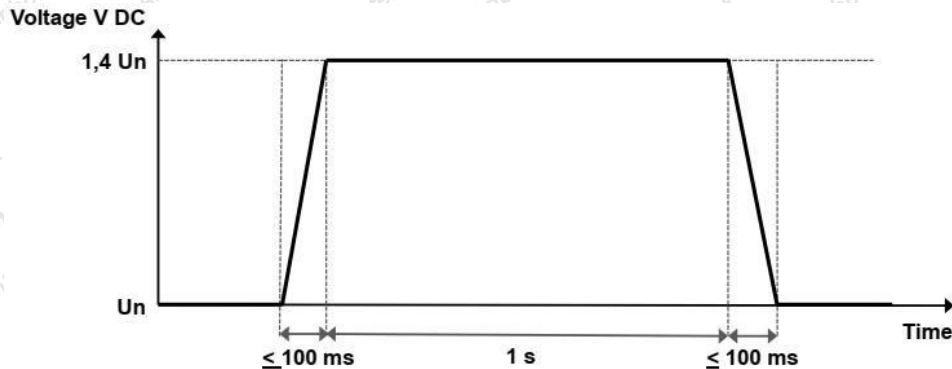
For temporary supply overvoltages up to 1,4 U_n lasting no more than 1 s the equipment shall fulfil **performance criterion B**.

Figure 7 — Temporary supply overvoltages (b)

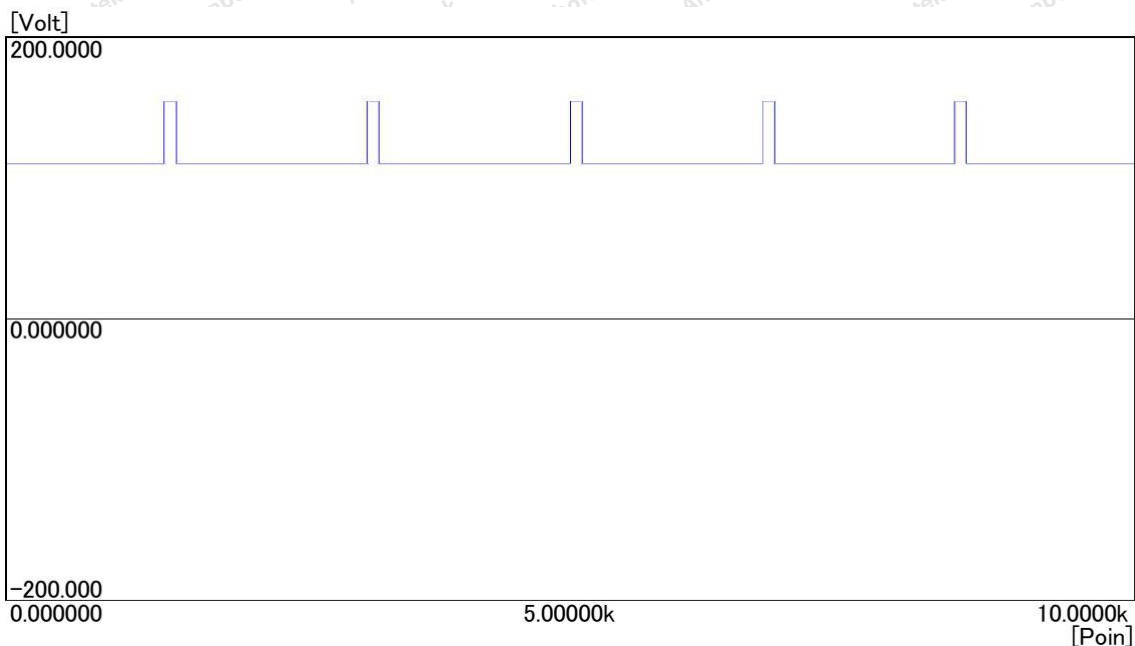
EUT : Fanless In-Vehicle Computer

Test Level : 154V (1.4 U_n)

Dwell time : 100ms

Result : Criteria A

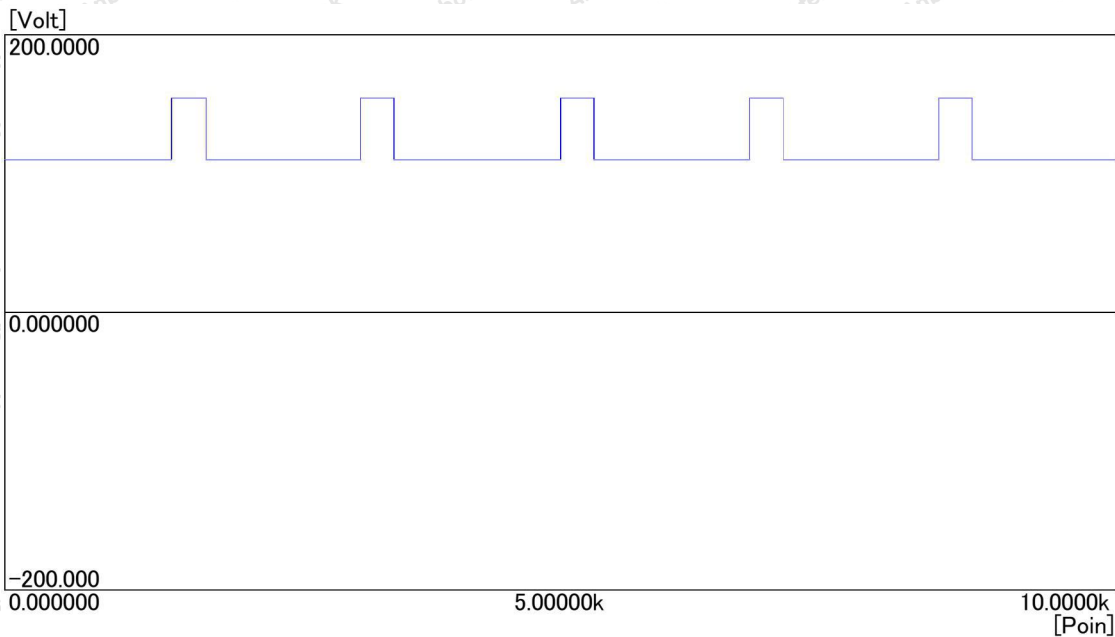
EUT : Fanless In-Vehicle Computer

Test Level : 154V (1.4 Un)

Dwell time : 1s

Result : Criteria A

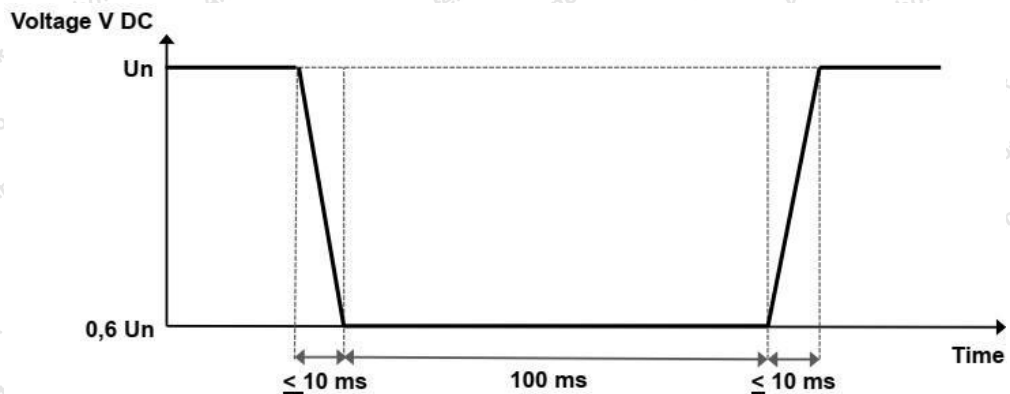
Temporary supply dips down to 0,6 Un not exceeding 0,1 s shall not cause deviation of function (performance criterion A).

Figure 8 — Temporary supply dips

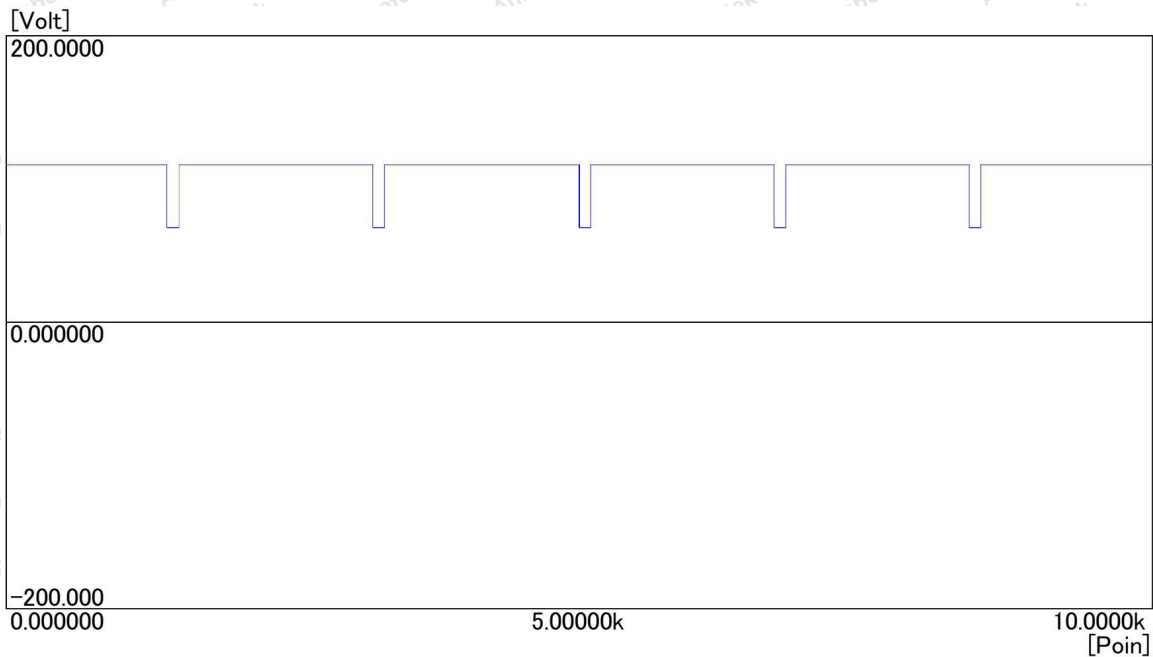
EUT : Fanless In-Vehicle Computer
Power Source (Un) : DC 110V
Test Level : 66V (0.6 Un)
Sequence number : 10
Interval time : 30s
Dwell time : 0.1s
Result : Criteria A

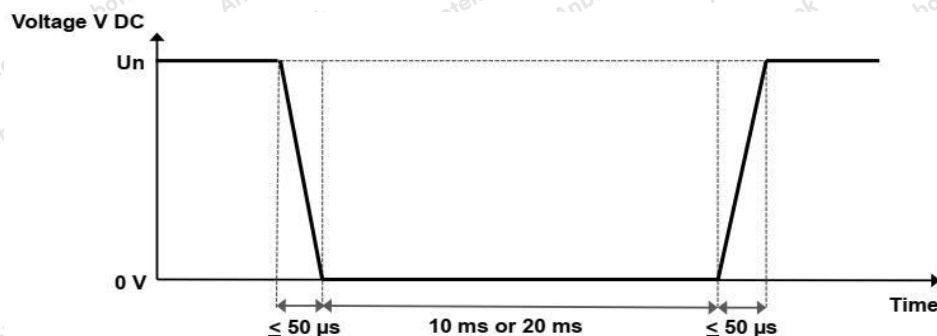
Class	Requirements	Duration of the interruption time Tint (See Figure 9)
S1	No performance criterion is requested but the equipment shall continue to operate as specified after the voltage interruption.	NOTE As defined in 5.1.1.4, this test is not required.
S2	The equipment shall behave according performance criterion A.	10 ms
S3	The equipment shall behave according performance criterion A.	20 ms

Figure 9 — Interruption of supply voltage

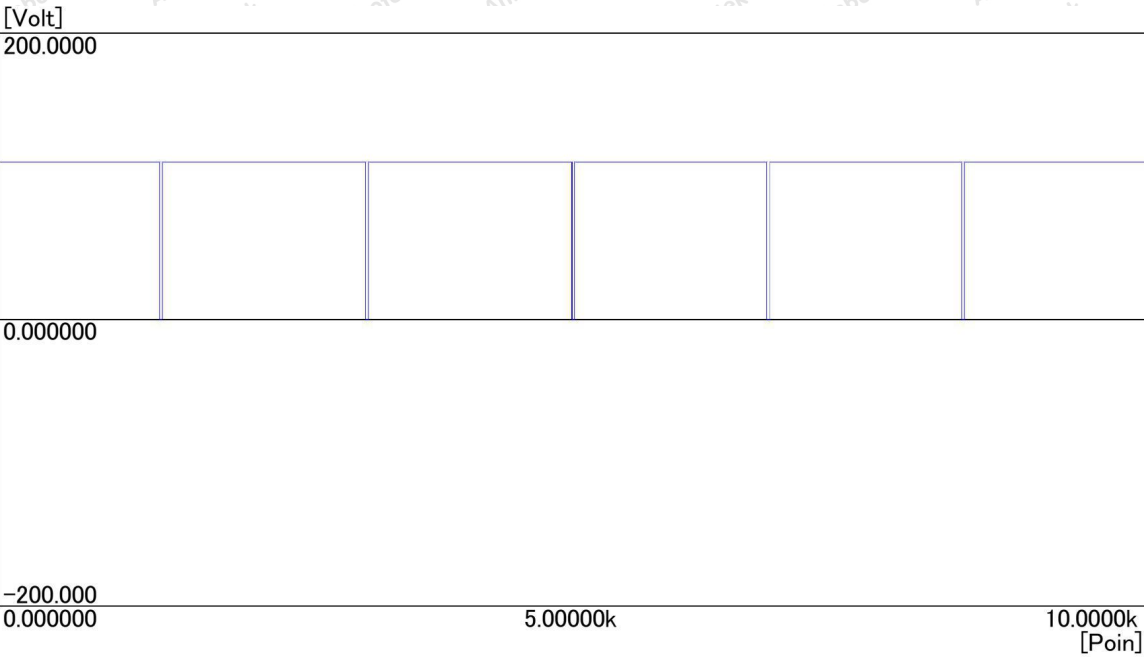
EUT : Fanless In-Vehicle Computer
Power Source (Un) : DC 110V
Test Level : 0V
Sequence number : 10
Interval time : 60s
Dwell time : 10ms (class S2)
Result : Criteria A

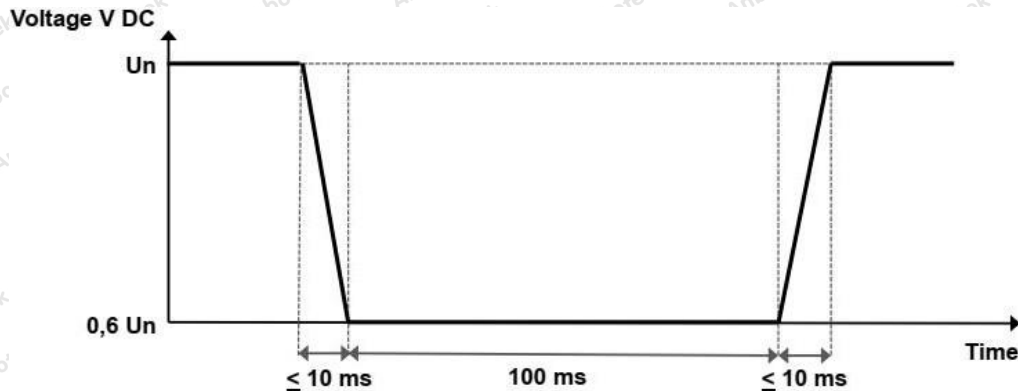
—Class C1: at 0,6 Un during 100 ms (without interruptions). **Performance criterion A;**

Figure 10 — Supply change-over Class C1

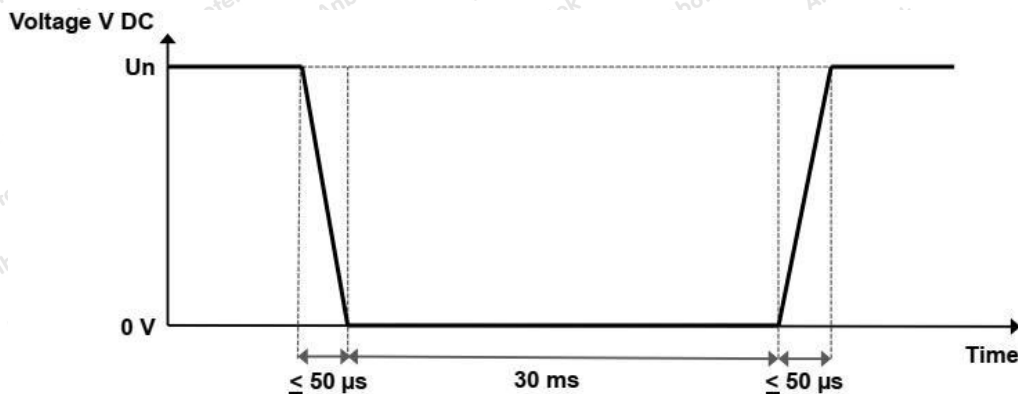
—Class C2: during a supply break of 30 ms starting at Un **Performance criterion B.**

Figure 11 — Supply change-over Class C2

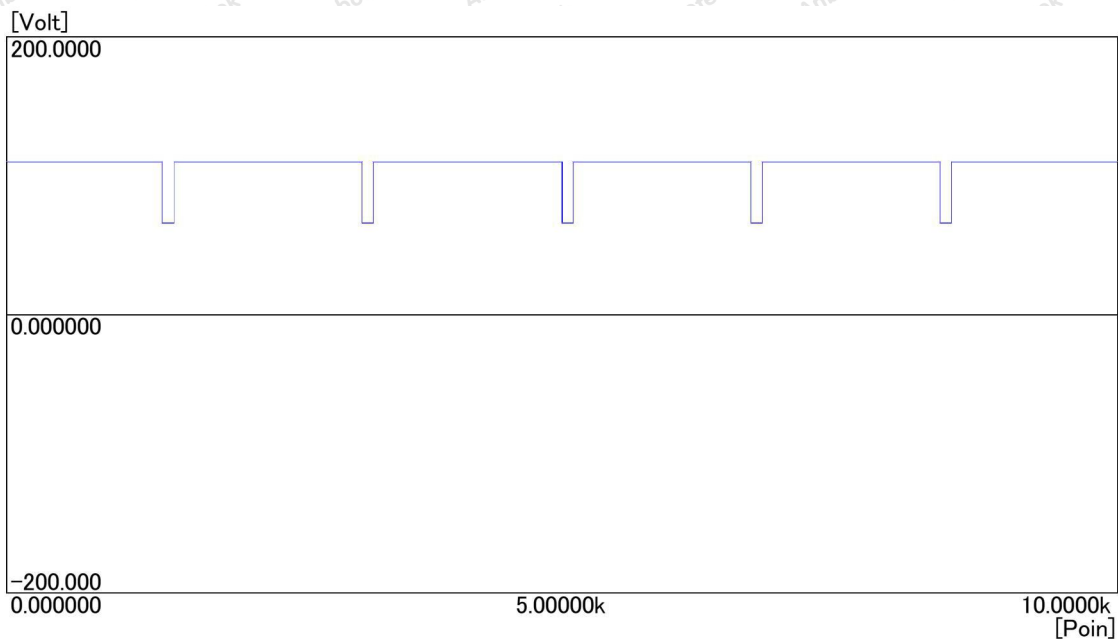
EUT : Fanless In-Vehicle Computer

Test Level : 66V (0.6 Un)

Dwell time : 100ms (class C1)

Result : Criteria A
